Land at Chartist Way, Tredegar Proposed Primary School Exploratory Investigation

Report Reference: ESP.7777b.3543

Prepared for:
Blaenau Gwent County Borough Council
Civic Centre,
Municipal Buildings,
Ebbw Vale
NP23 6XB

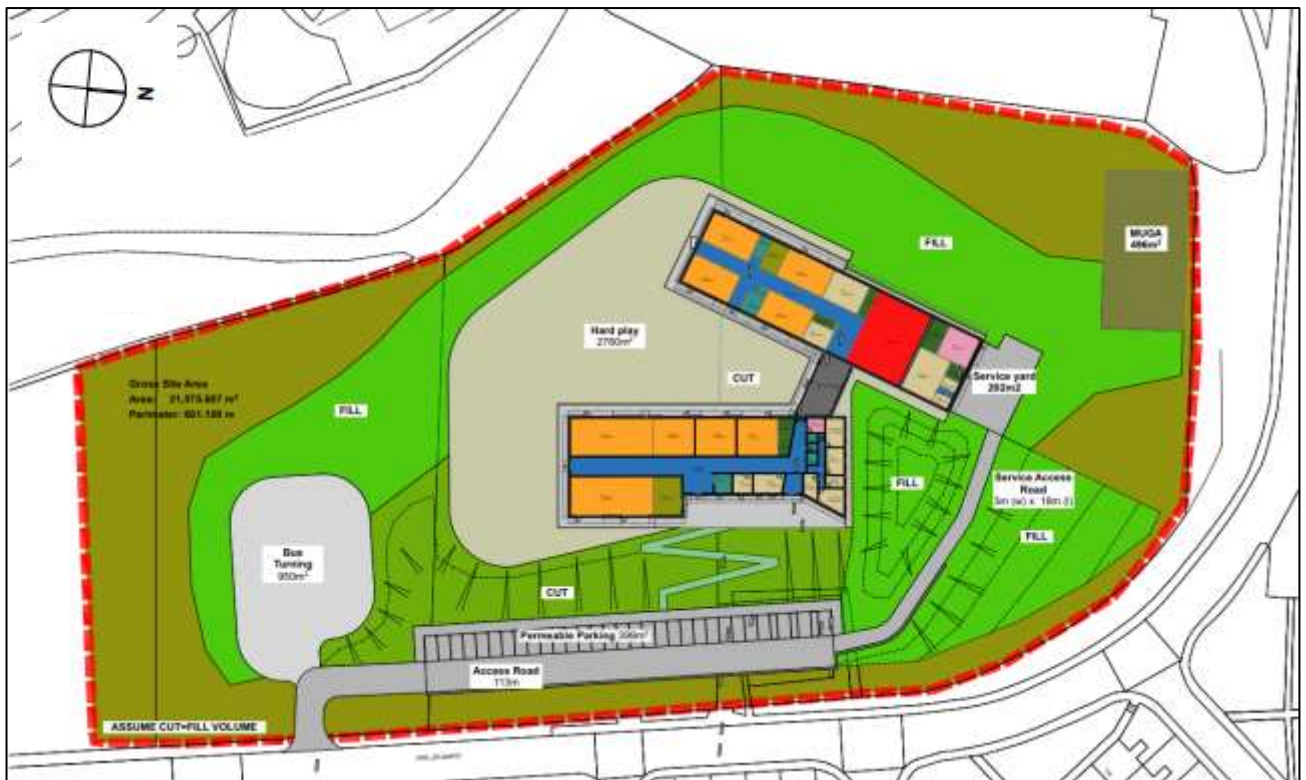
Insert 1 - Proposed Development Plan (Client Ref: TS1297 Sk04/S1)

The proposed development will comprise a single storey school building with associated play areas, access road, bus turning circle, car parking and landscaped areas. We understand that in order to construct a suitable development plateau, ground levels in the east will be lowered, and the excavated soils used as fill to raise ground levels in the west, however specific levels are not currently available. The proposed development layout is presented as Insert 1.
