Dolines in the Mynydd Llangynidr  
preferred area of search

Photos taken by Professor John Gunn,  
Accompanied by Stuart Reid (CCW)  
11<sup>th</sup> July 2012

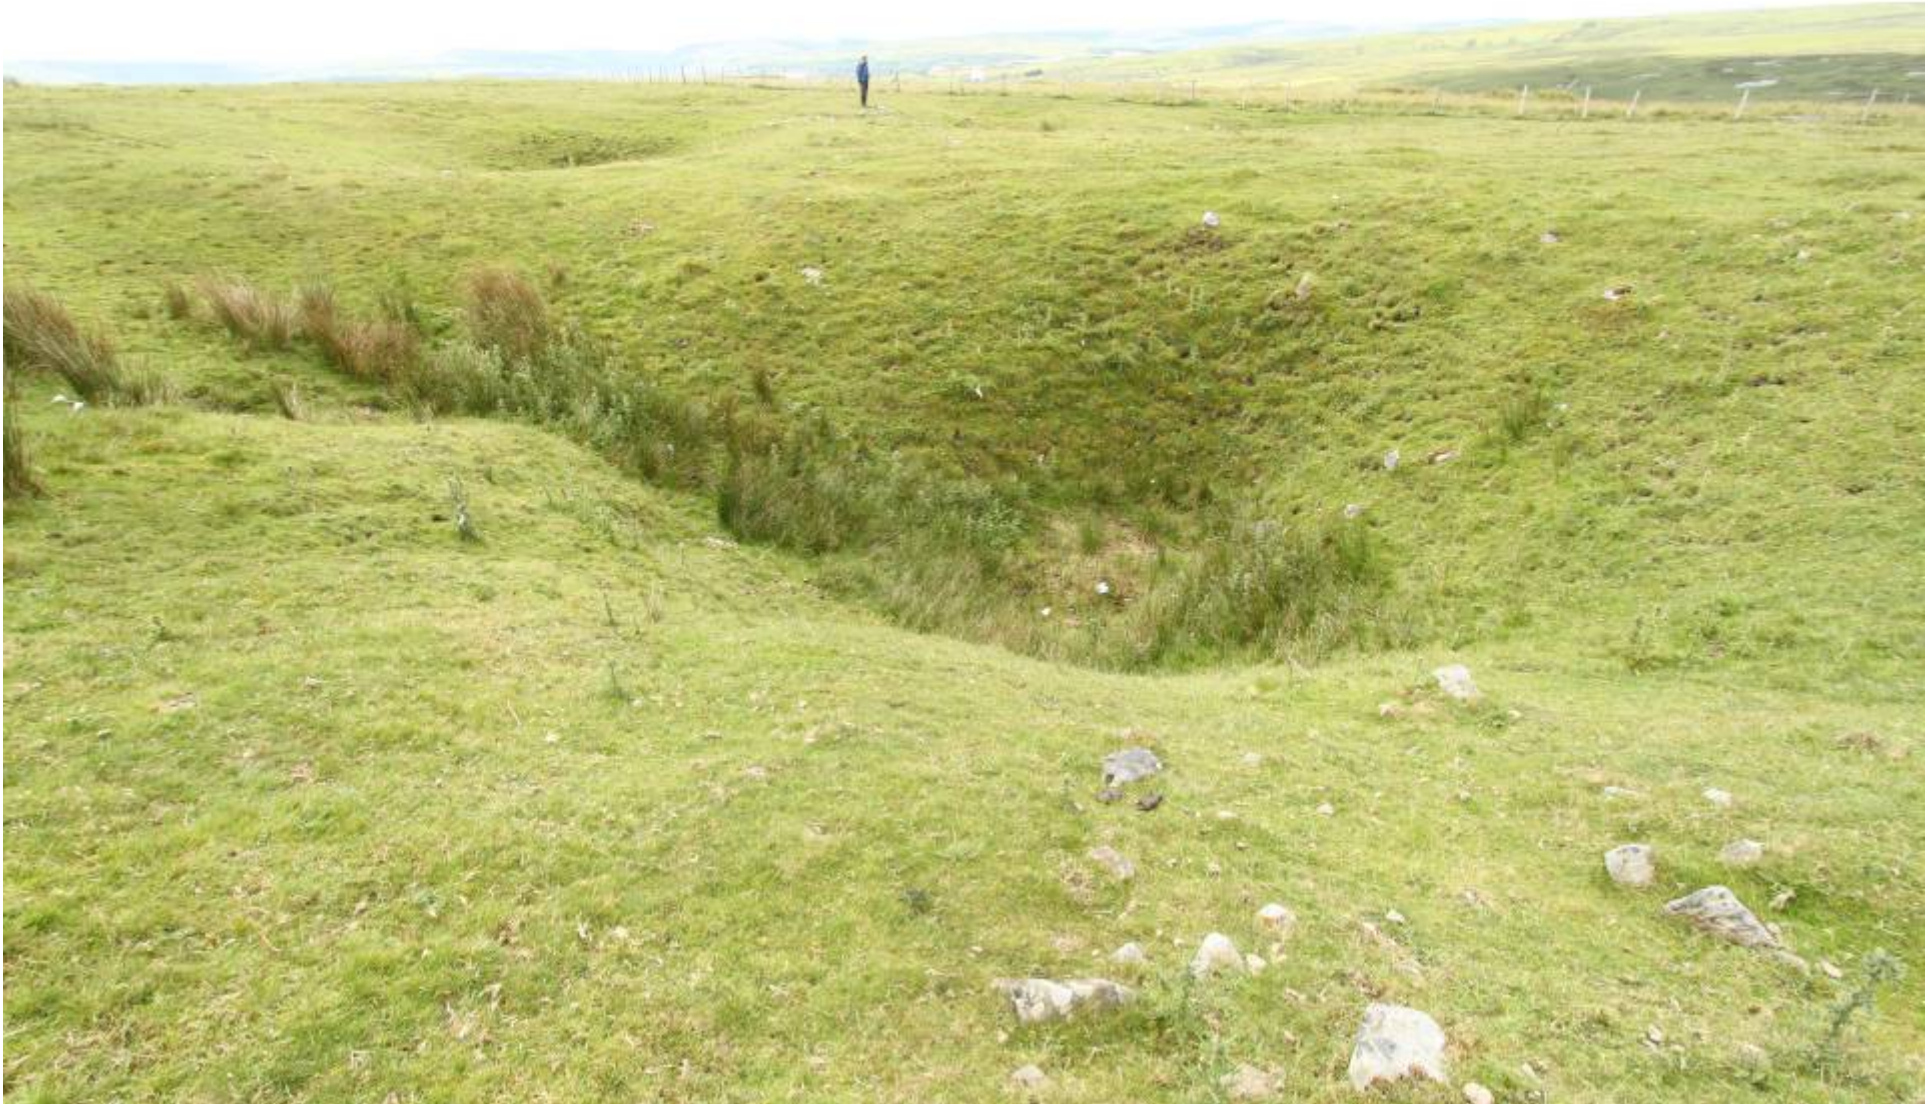
Interstratal karst doline CD1 (fence at quarry boundary in background)  
There is no limestone in the floor or sides; the visible boulders are all sandstone.  
Area of 'Collapsed and Soliflucted Grit on Carboniferous Limestone'

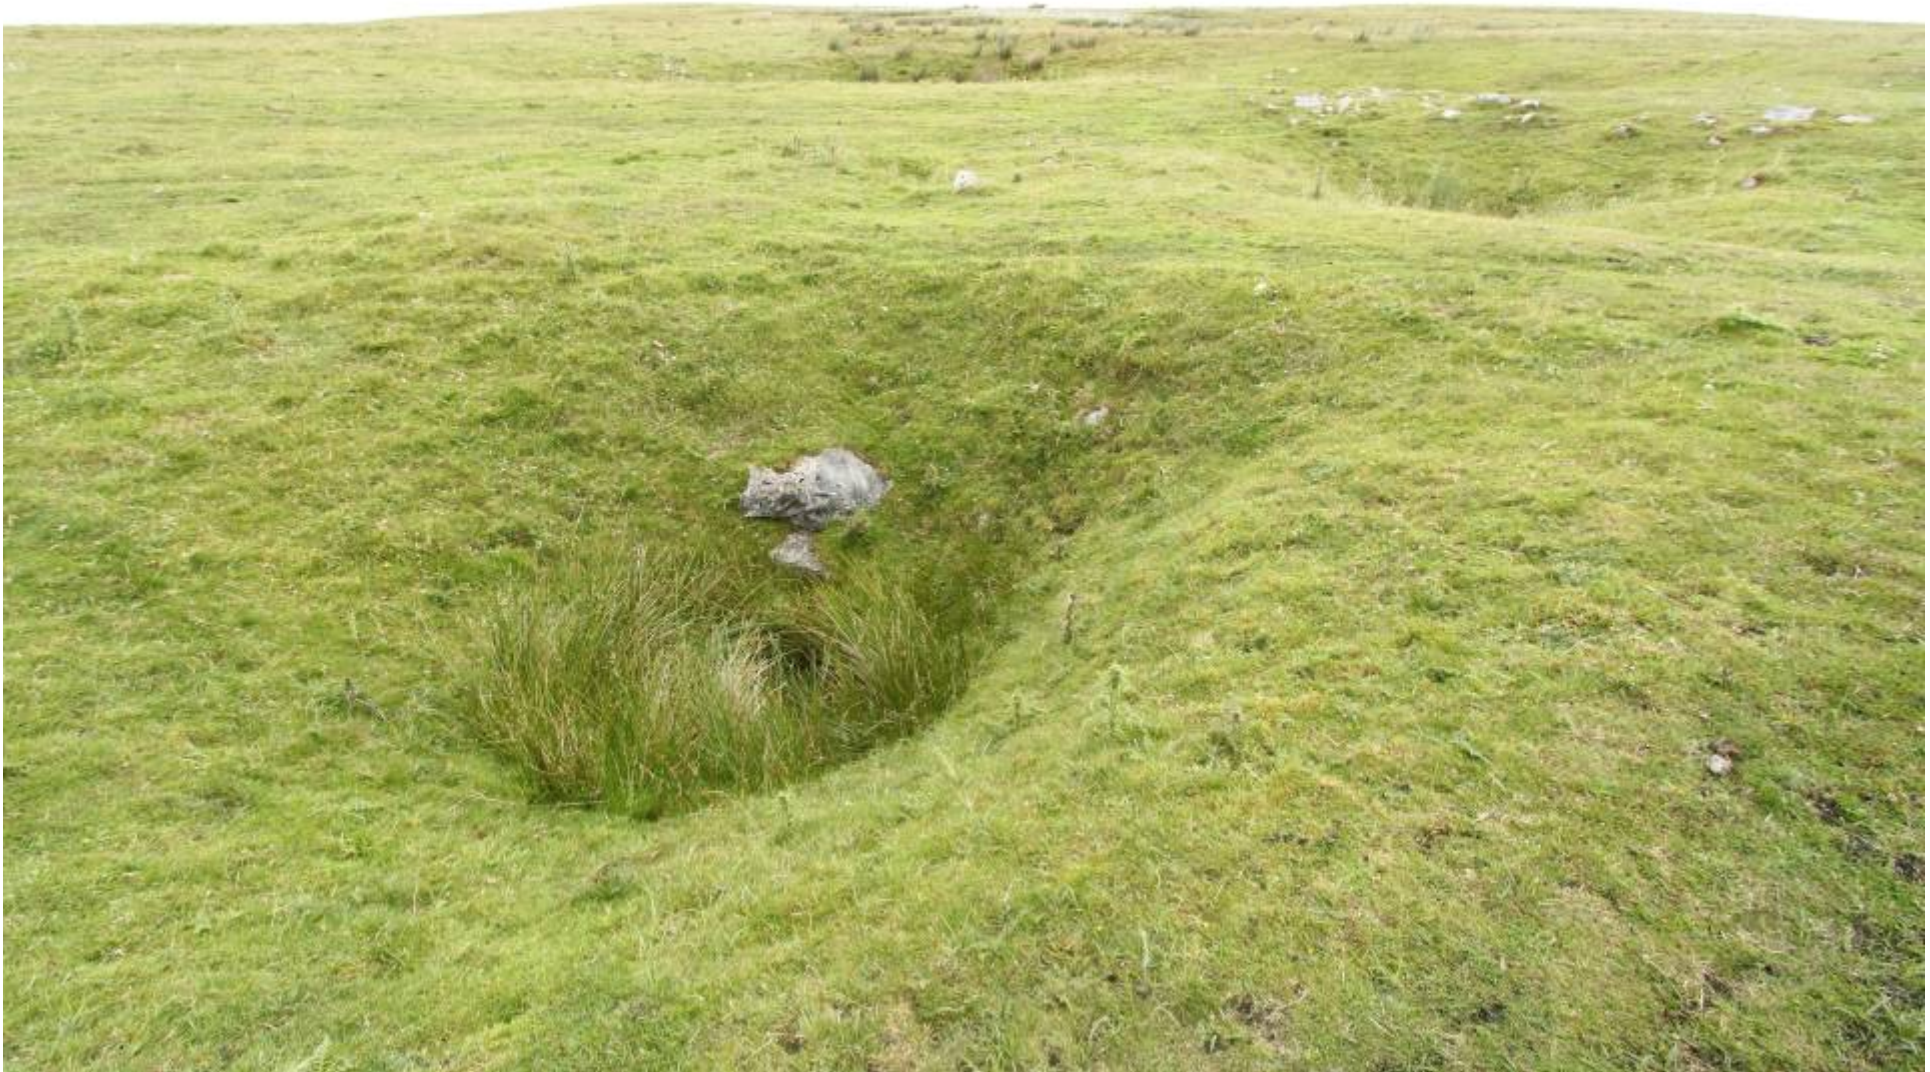
Doline CD2 in foreground. This is the only doline examined that clearly has in situ limestone bedrock exposed in the walls (i.e. it is a clear example of a solution doline)

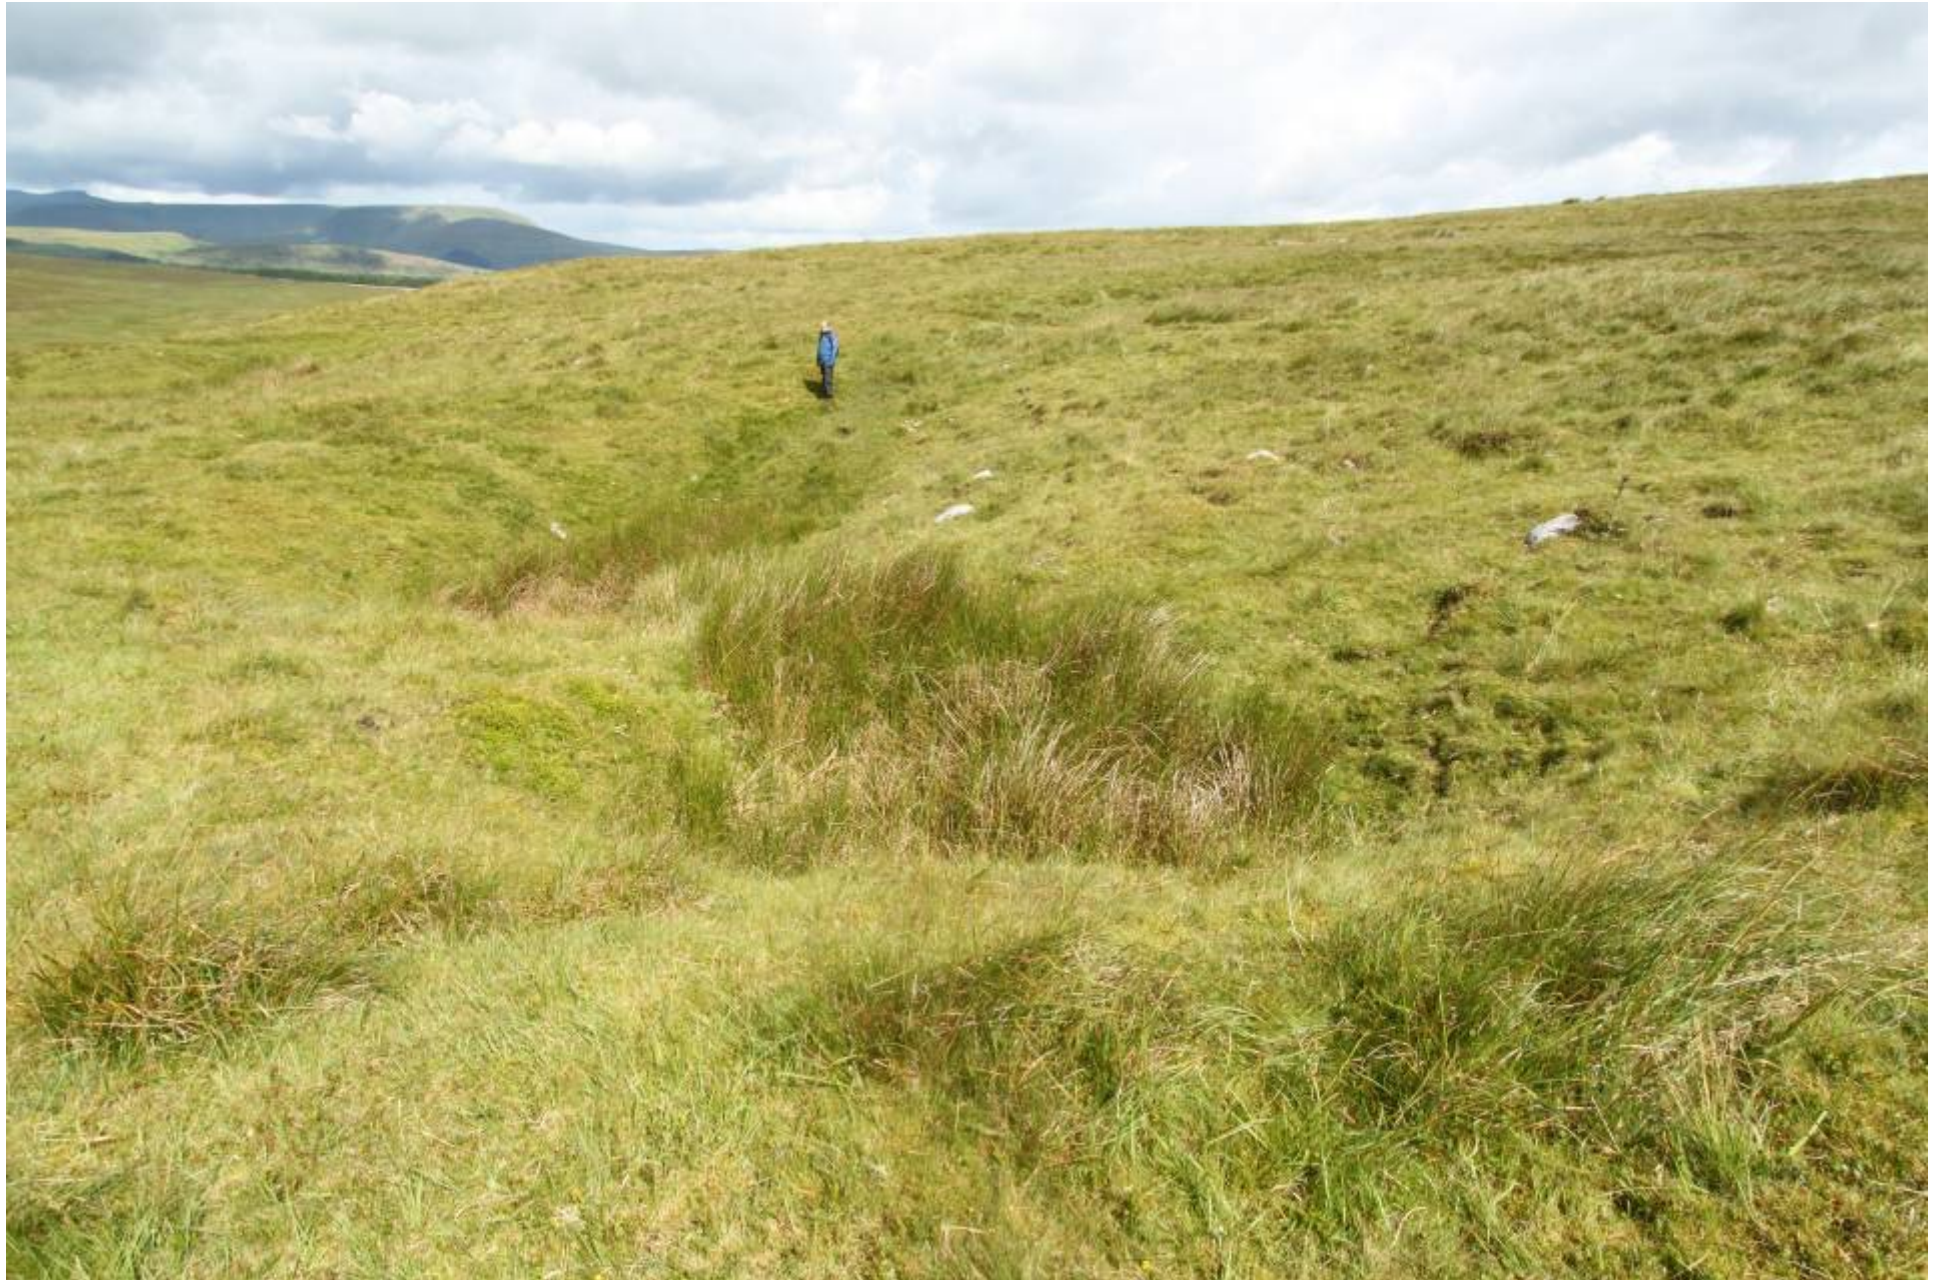
Doline CD3 – one of several aligned across the slope. No limestone cropping out.  
Part of the area of Collapsed and Soliflucted Grit on Carboniferous Limestone.

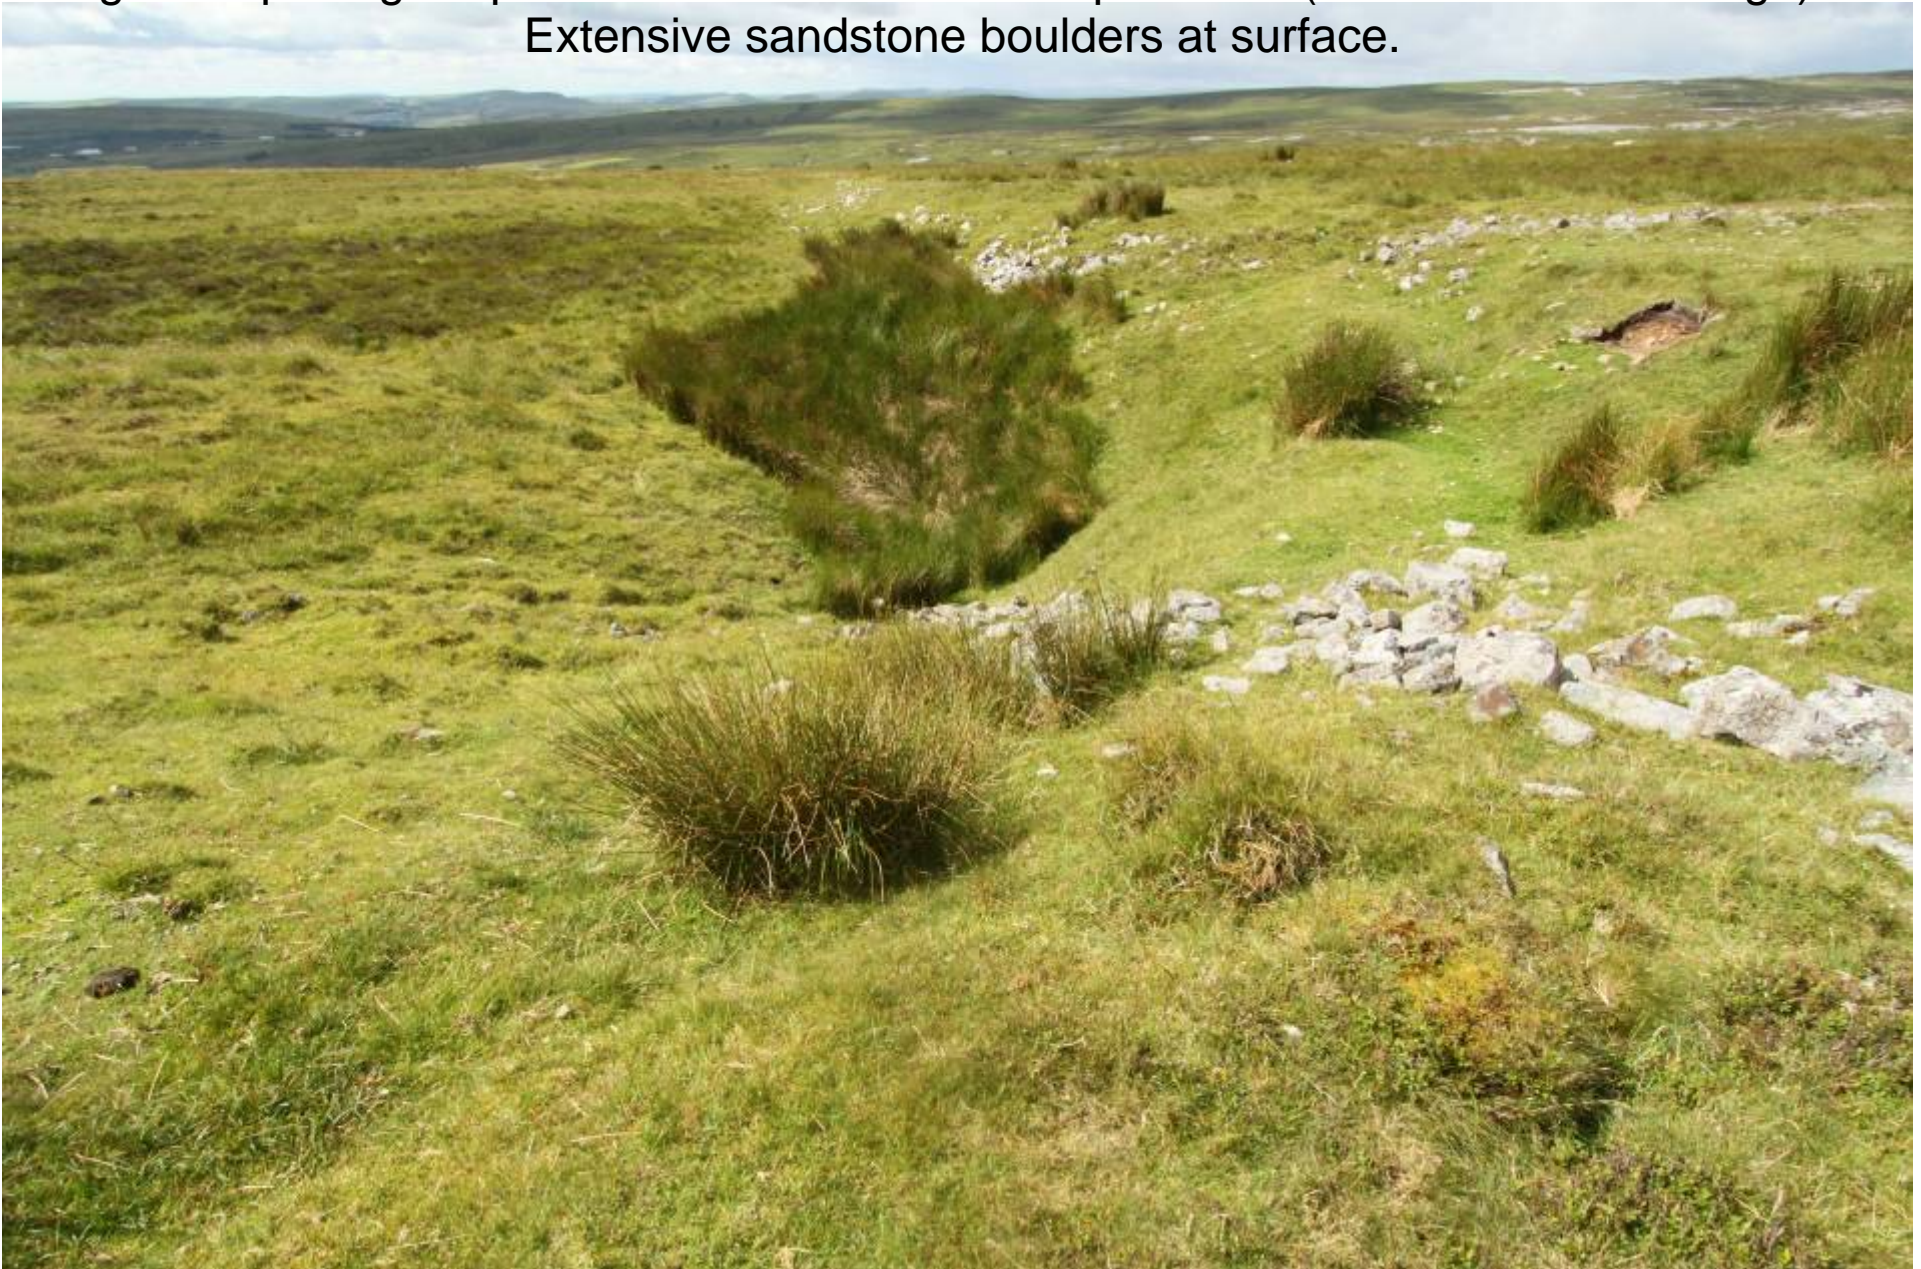
Caprock doline CD4, about 3m deep. Scar to right provides evidence of active geomorphological processes and rushes mark percoline (concentrated recharge). Extensive sandstone boulders at surface.

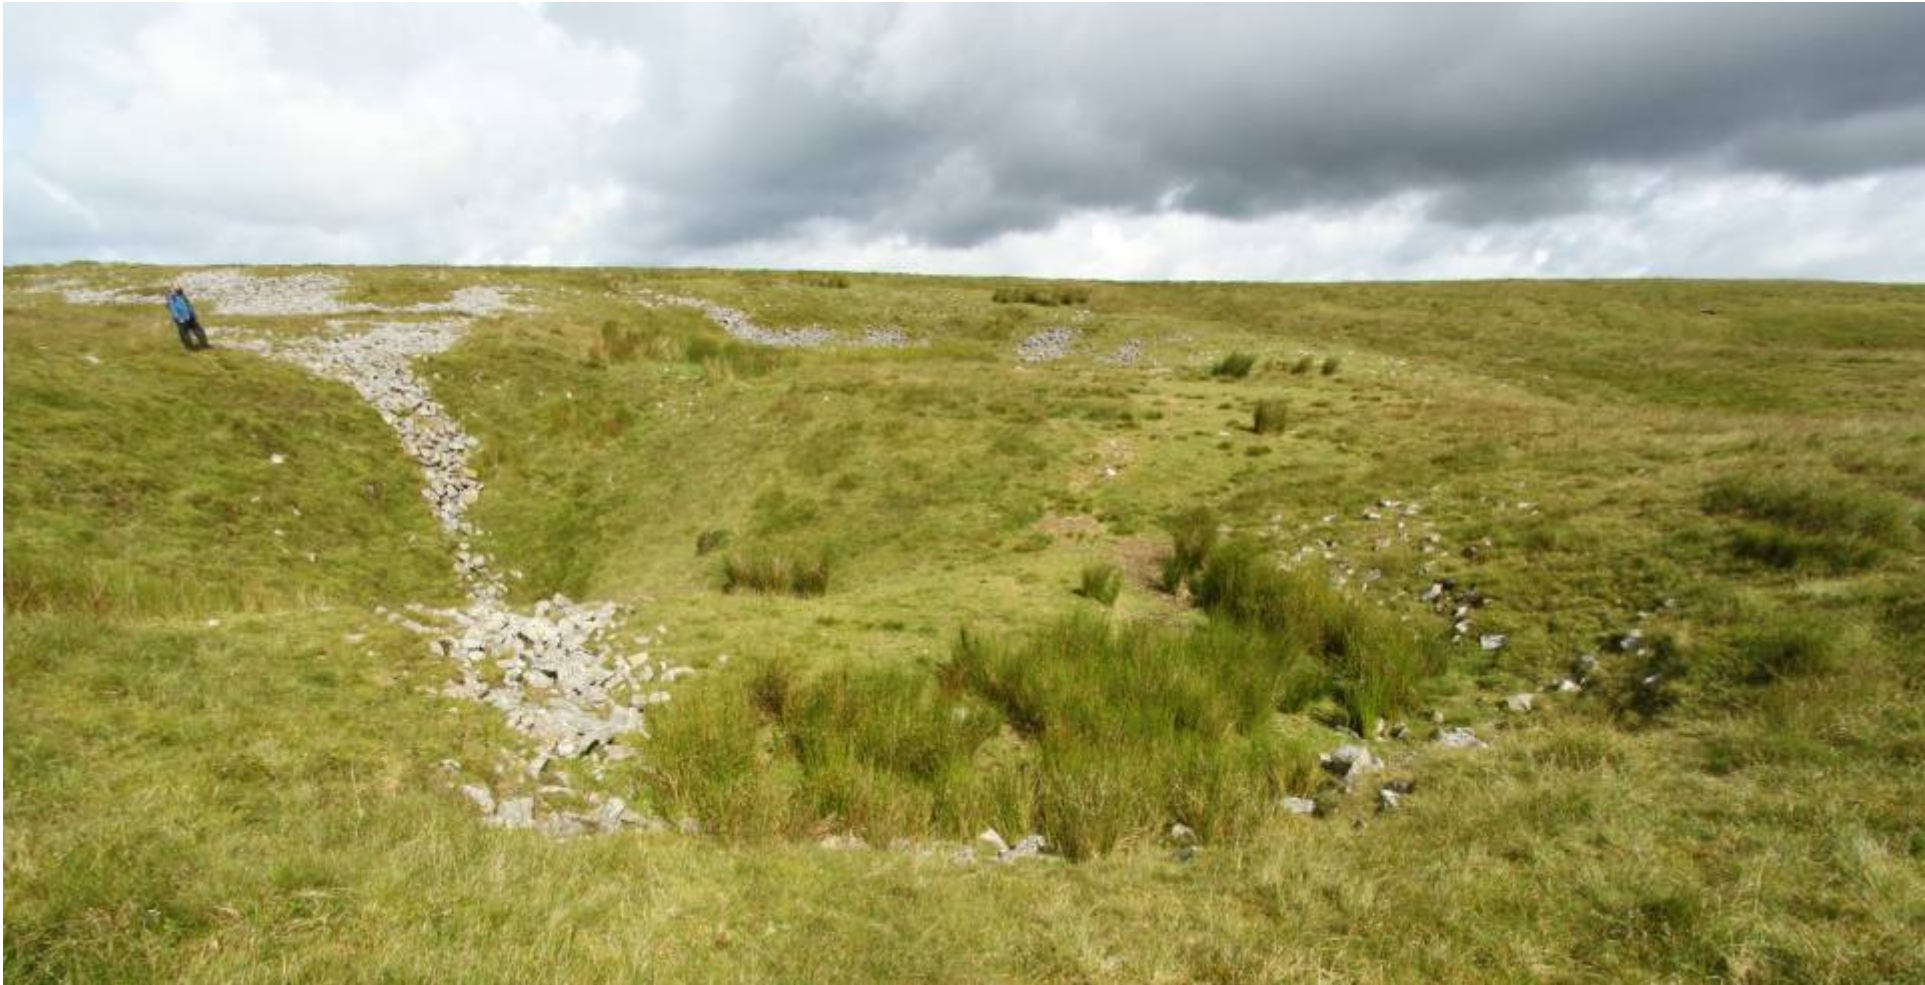
CD5. An area of large caprock dolines (up to 7m deep; see next image) and extensive sandstone scree

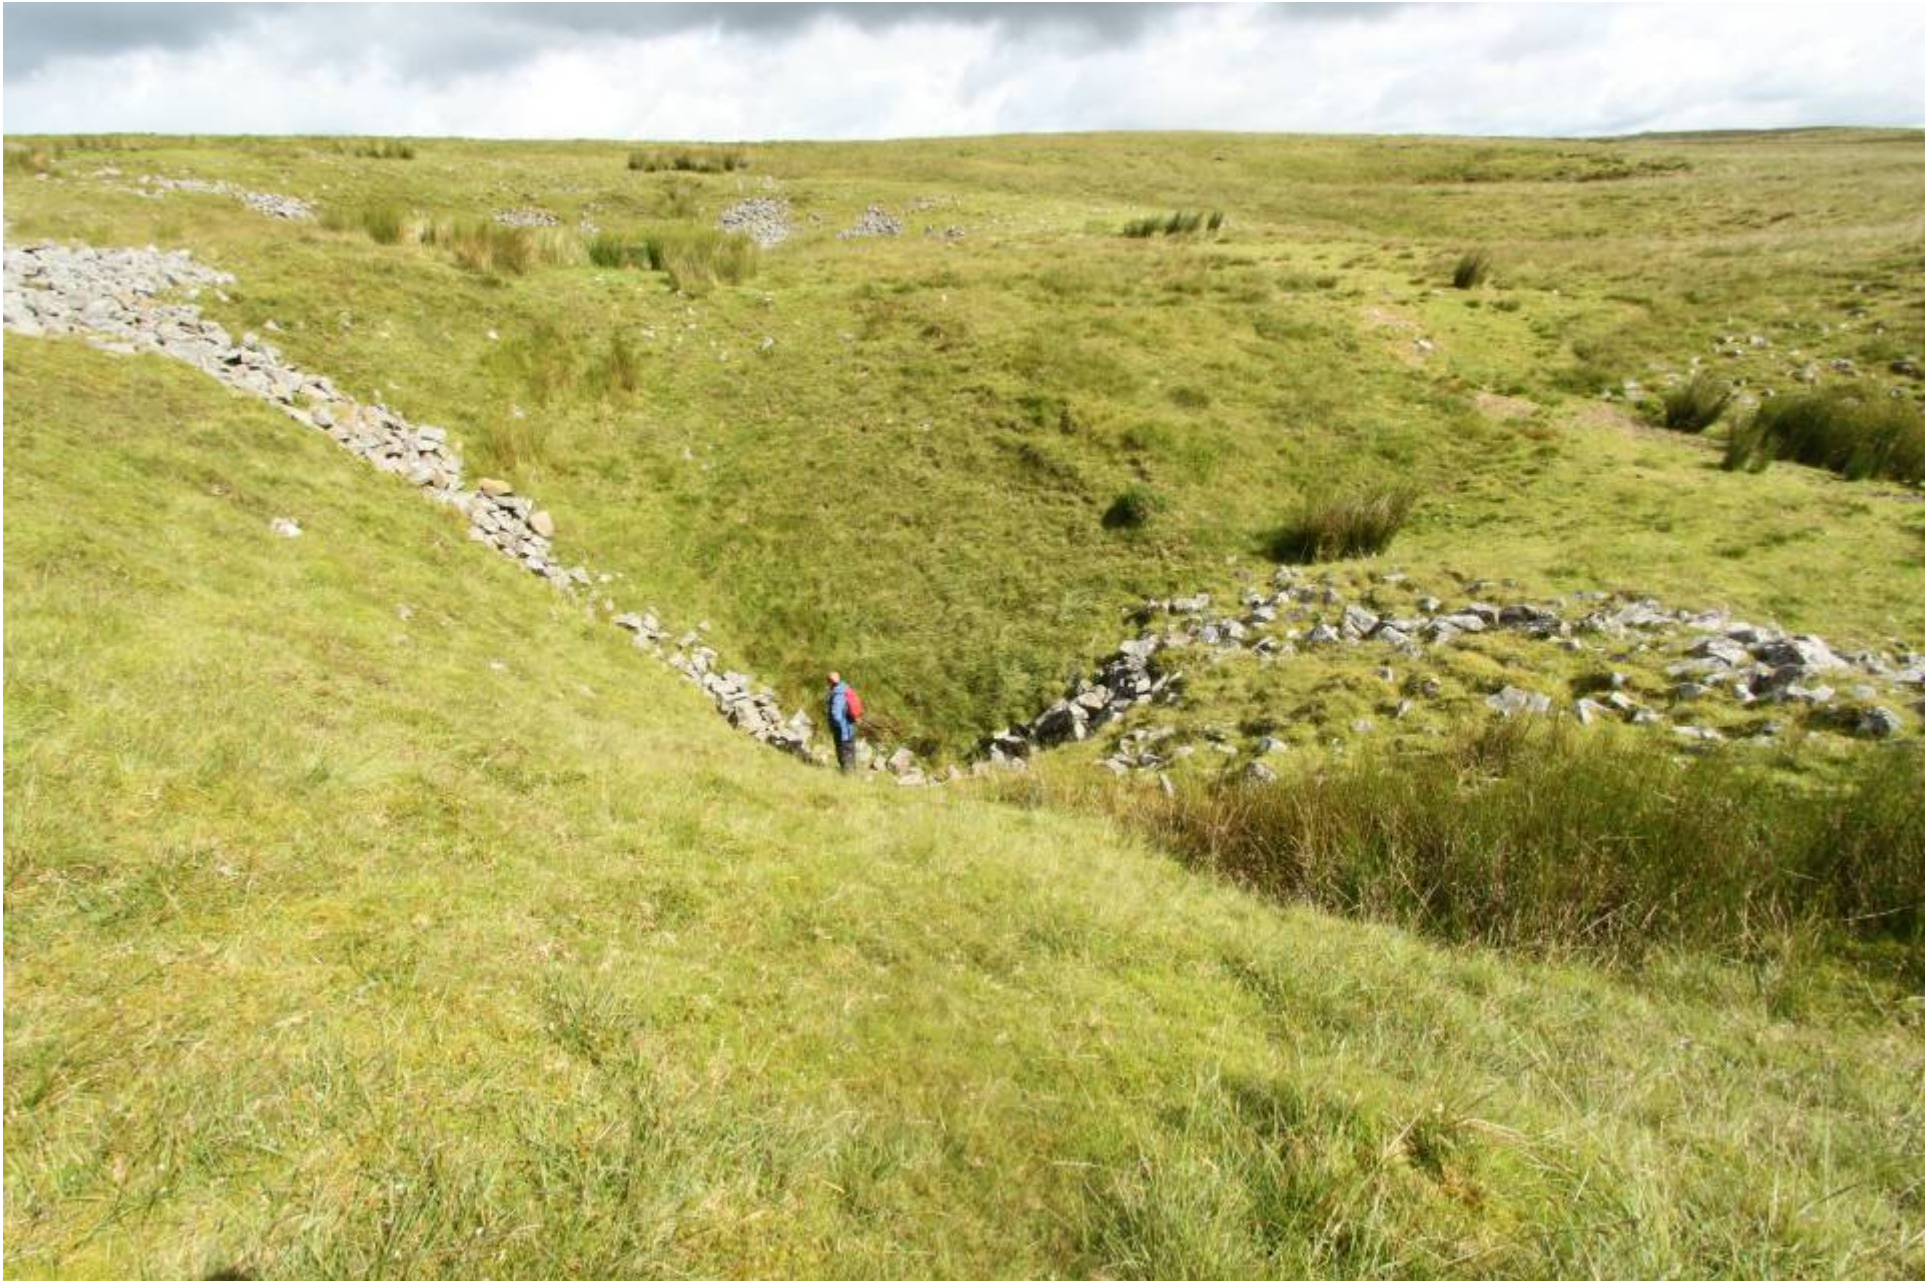
Detail of caprock doline shown on previous slide
